# Elite Home Inspection Report

## Sample – Elite Home Inspection Report

**Prepared By:**  
Structure & Site  
Inspection Services LLC

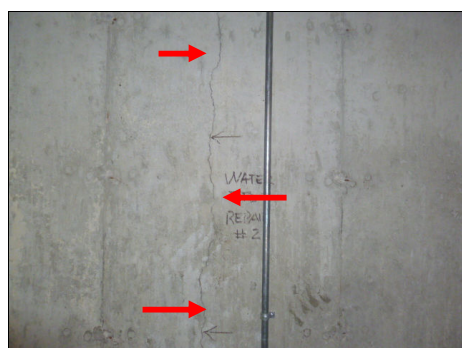
- **Monitor:** Settlement cracks were observed in the foundation walls. This implies that some structural movement of the building has occurred. Cracks of this type should be watched for any sign of additional movement. In the absence of any sign of ongoing movement, repair should not be necessary.

Recommend pressure filling foundation crack.

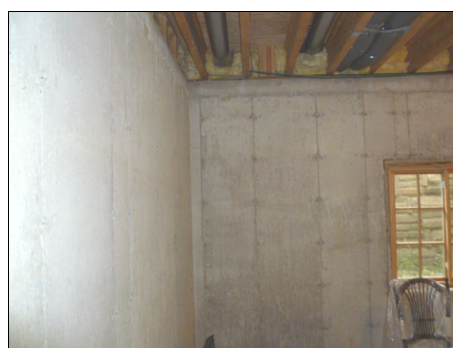
Recommend sealing foundation walls.

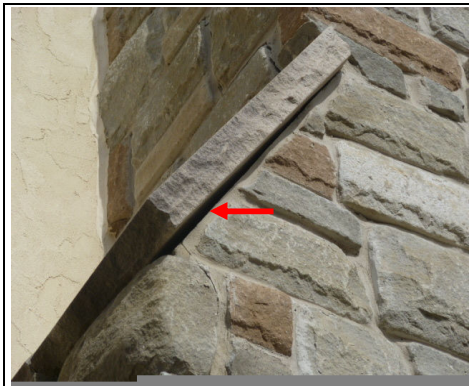
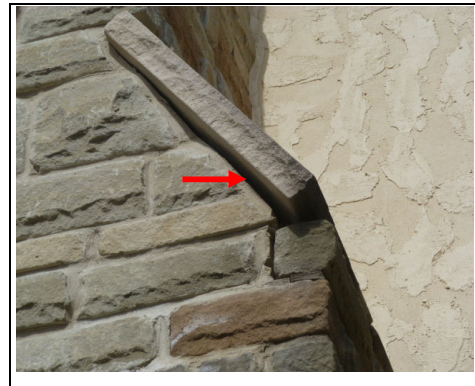
- **Repair:** The masonry chimneys need re-pointing (replacing the mortar between the stone) to avoid damage.

View of loose masonry tile and missing mortar at various areas of chimneys.

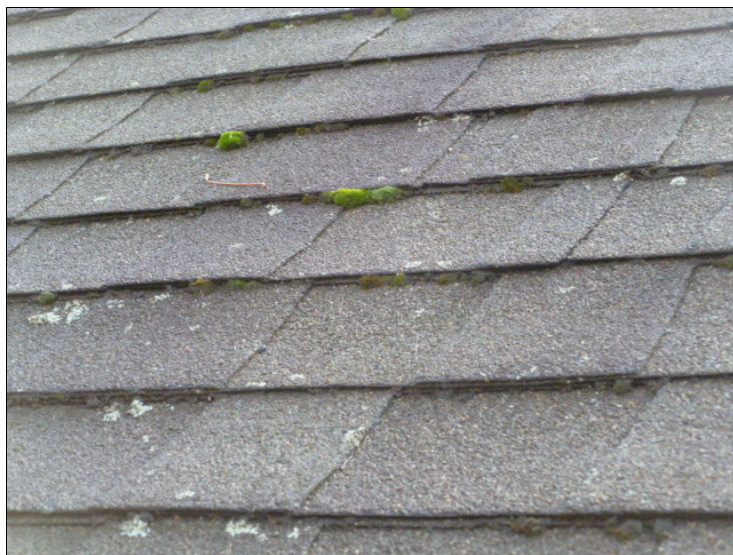
- **Monitor:** The roofing is in good condition. We did not see evidence of active leaks or need for immediate major repair.
- **Improve:** Organic growth on roof surfaces should be treated to prevent decay of roof material. Recommend contacting [www.roofmedic.com](http://www.roofmedic.com), a local company that applies an EPA registered chemical to the roof that removes the moss and other organic material for the surface material.

View of moss growth on rear slope.

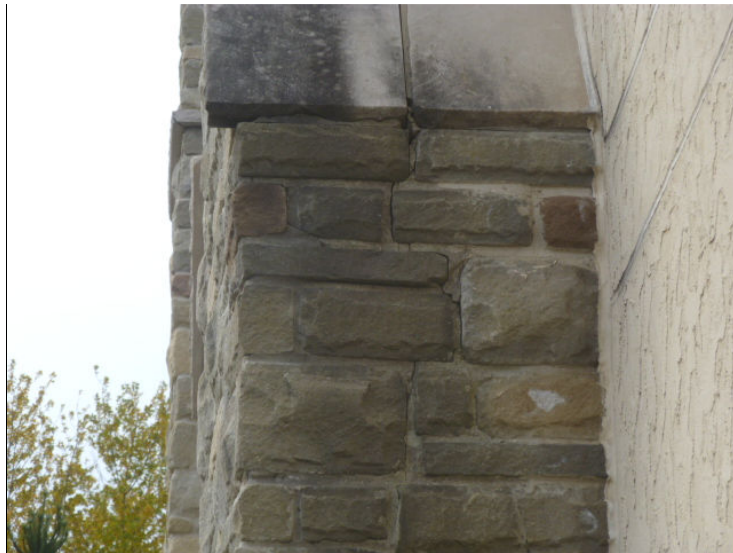
Loose mortar and stone observed on chimneys.

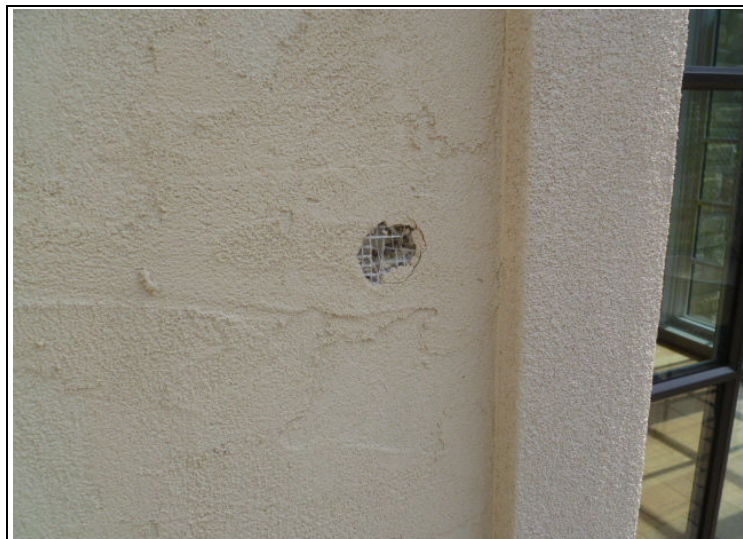
- **Repair:** The exterior insulation finishing system (EIFS) requires repair. Multiple areas of staining, damage and decaying caulk observed. Additional information below.
- **Repair:** Caulk at dissimilar materials, example stone to siding to reduce moisture and pest infiltration.
- **Repair:** Vegetation growing on or near exterior materials should be kept trimmed away from siding, window trims, and the eaves to reduce risk of insect and water damage.

View of damage at EIFS exterior wall material.

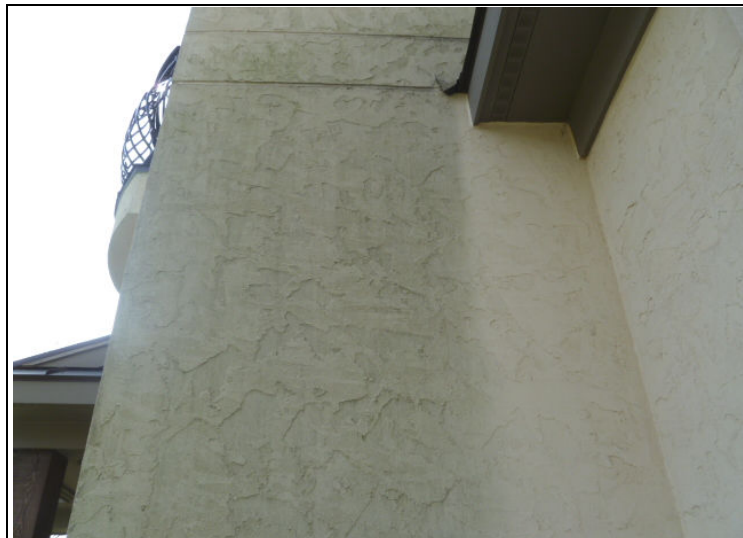
View of water staining on EIFS material.

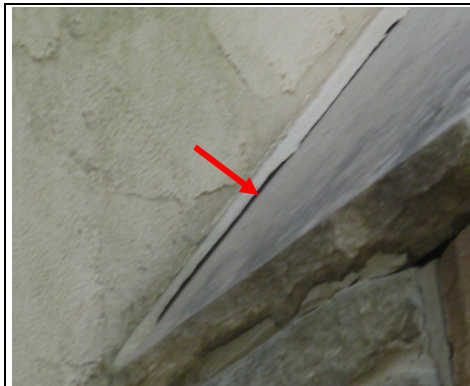
View of decaying caulk at chimney.

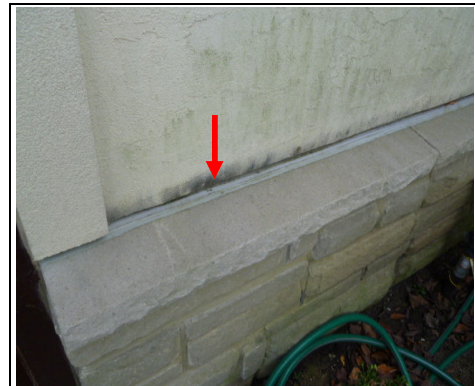
EIFS water damage at sill.

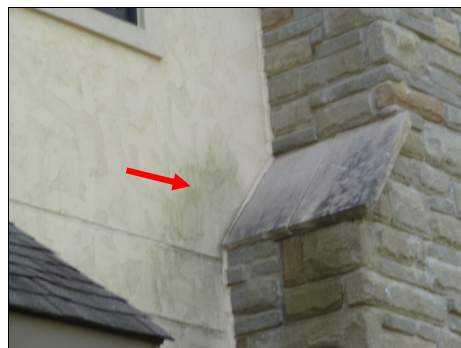
Staining of EIFS at chimneys.

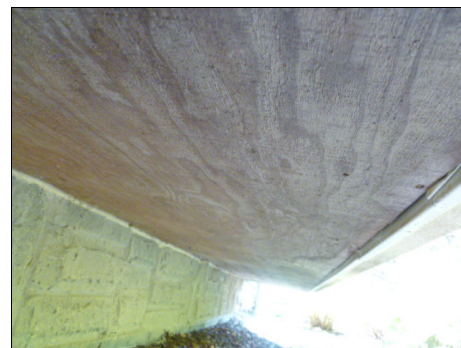
Exposed wood at underside of bay framing.

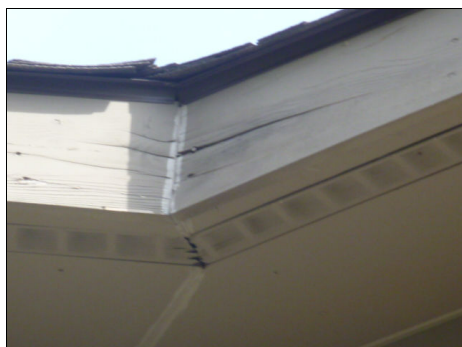
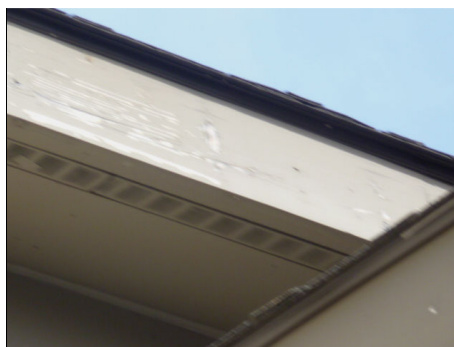
- **Repair:** The soffit and fascia materials should be painted.

Water damage and exposed wood to fascia board.

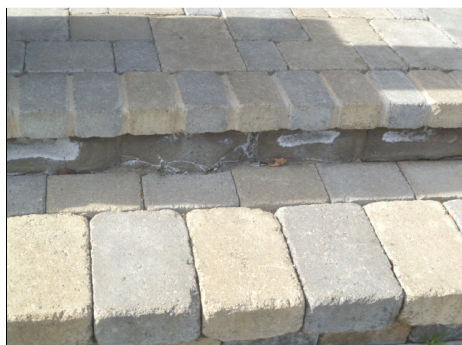
- **Repair:** The porch masonry mortar is deteriorating noticeably. Repairs or rebuilding may eventually be needed here and may involve significant expense.

Masonry and mortar decay at front porch.

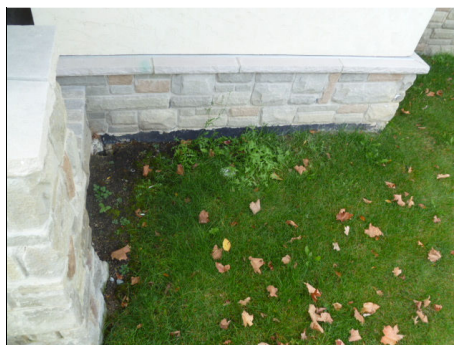
- **Repair:** The grading should be improved to promote the flow of storm water away from the house. This can often be accomplished by the addition of top soil. The ground should slope away from the house at a rate of one inch per foot for at least the first ten feet. At least eight (8) inches of clearance should be maintained between soil level and the bottom of exterior wall siding.

Low grade at front wall.

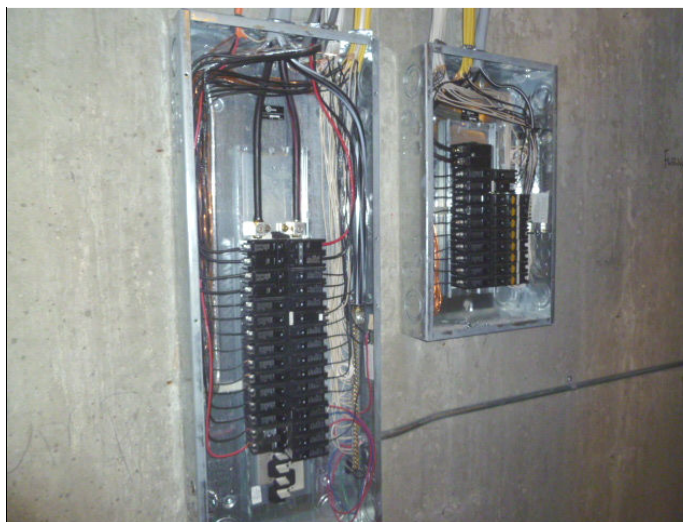
Main and sub distribution panels in good order.

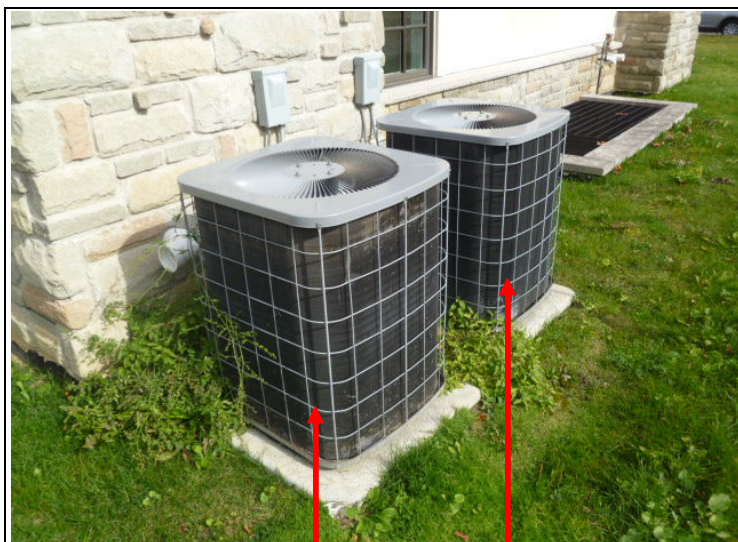
Exterior A/C unit. 2<sup>nd</sup> floor unit. 1<sup>st</sup> floor & basement unit. First floor unit semi-inoperative.

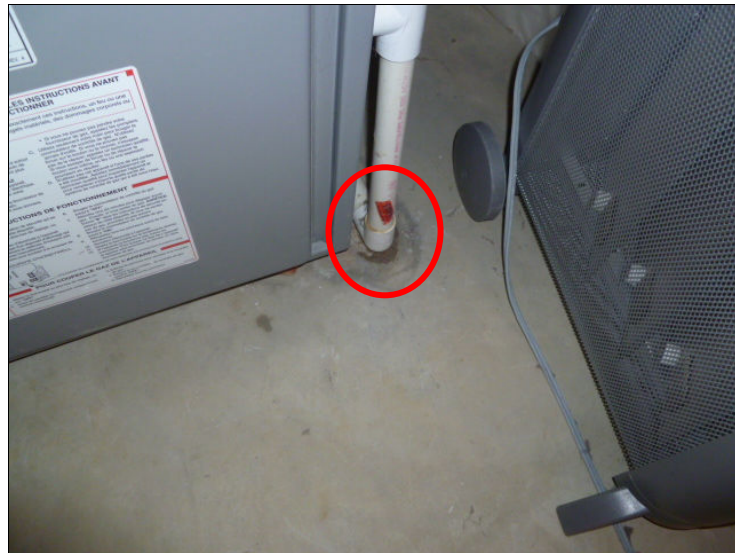
- **Repair:** The air conditioning condensate line appears to be obstructed on the 2<sup>nd</sup> floor unit.
- **Improve:** The outdoor unit of the air conditioning system requires cleaning.
- **Improve:** Recommend covering the exterior A/C unit during the winter months. Also, turn breaker off at electrical panel to ensure that the unit is not accidentally turned on during the winter months, which can cause significant damage.
- **Repair:** The first floor air conditioning system was semi-inoperative at the time of the inspection. The condenser unit did not respond properly to controls and the temperature of the air was not as cool as expected. A qualified heating and cooling technician should be consulted to further evaluate of this condition and the remedies available.

Condensate line leak on 2<sup>nd</sup> floor unit.

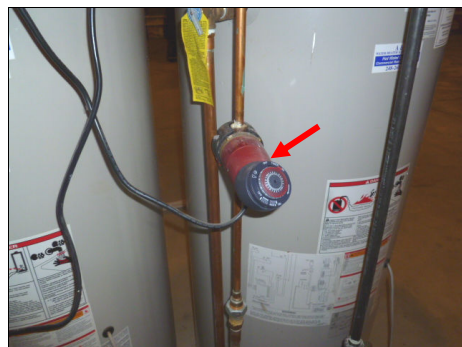
- **Monitor:** Water heaters have a typical life expectancy of 7 to 12 years. The existing unit is approaching this age range.
- **Repair:** The re-circulating pump for the hot water tanks appears to be inoperative.

Re-circulating pump inoperative.

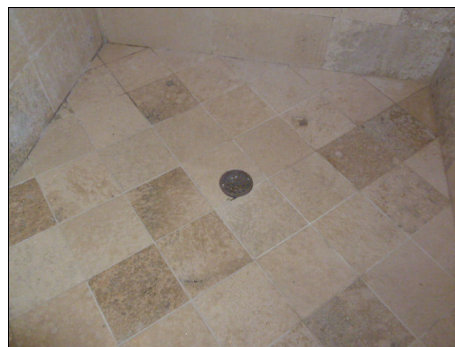
- **Repair:** Cracked, deteriorated and/or missing shower stall grout and caulk should be replaced.
- **Repair:** Cracked, deteriorated and/or missing bathtub enclosure caulk should be replaced.

Master shower grout damage.

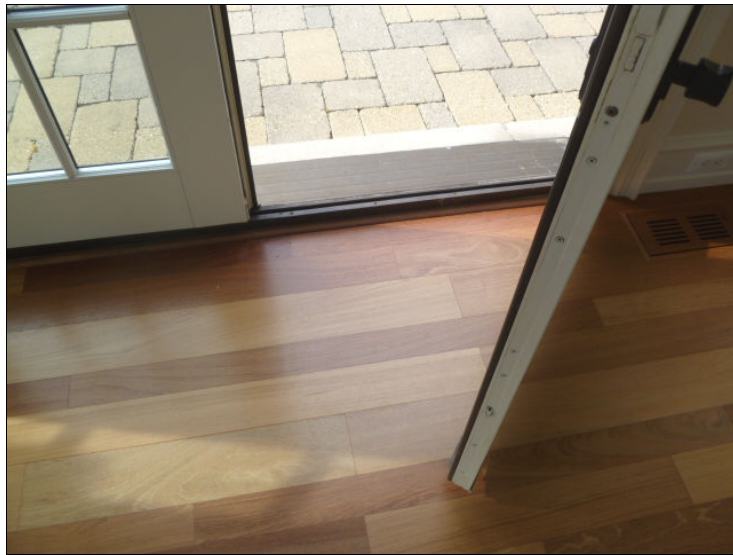
- **Repair:** Living room exterior doors should be trimmed or adjusted as necessary to work properly.

All three sets of French doors are difficult to open and close due to improper alignment within the frames.

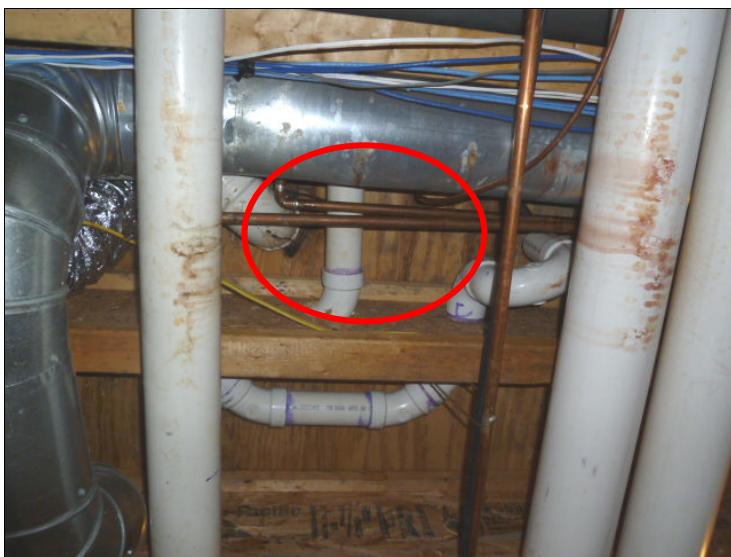
- **Repair:** Signs of mold growth were observed in the floor framing materials. Mold growth is a reaction to sustained moisture infiltration and the condition should be further evaluated. Mold growth within an enclosed environment can be detrimental to the inhabitant's health. Typically, removal of all contaminated materials and eliminating the moisture infiltration are the steps necessary to correct the situation. Visit [www.epa.gov/mold](http://www.epa.gov/mold) for more information.

Mold growth on floor framing deck material.
